# NuVision TM800A510L Charging Port Replacement

This Guide is to assist those who have found that their charging port for their device won't let the device charge correctly and needs replaced.

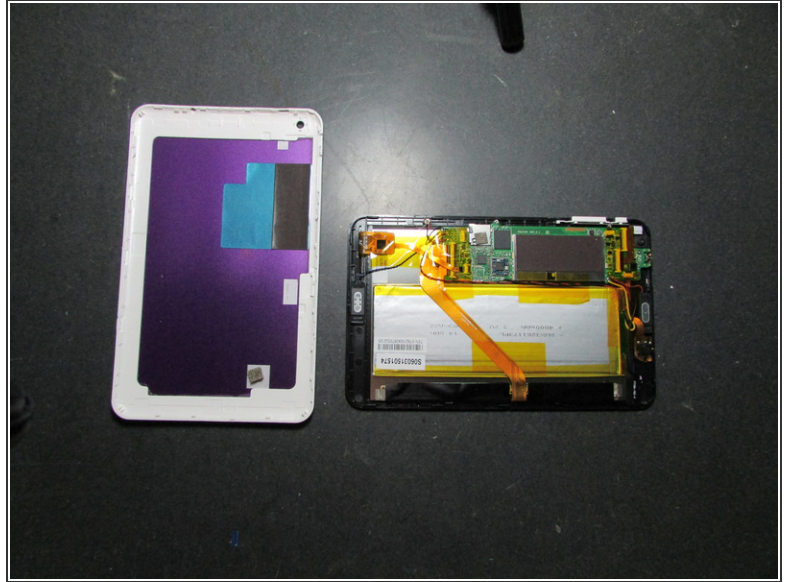
## Step 1 — Charging Port

- Use a Heat Gun to loosen the adhesive on the underside of the back cover.
  - Use some prying tools to lift the back cover off of the device.
- ⓘ I recommend heating up the device up to 'just barely too hot to touch' and then prying sides up one at a time.
- ⚠ Although, you can use either plastic or metal prying tools, metal prying tools may scratch the device. Make sure not to damage power and volume buttons when prying the cover off as well.

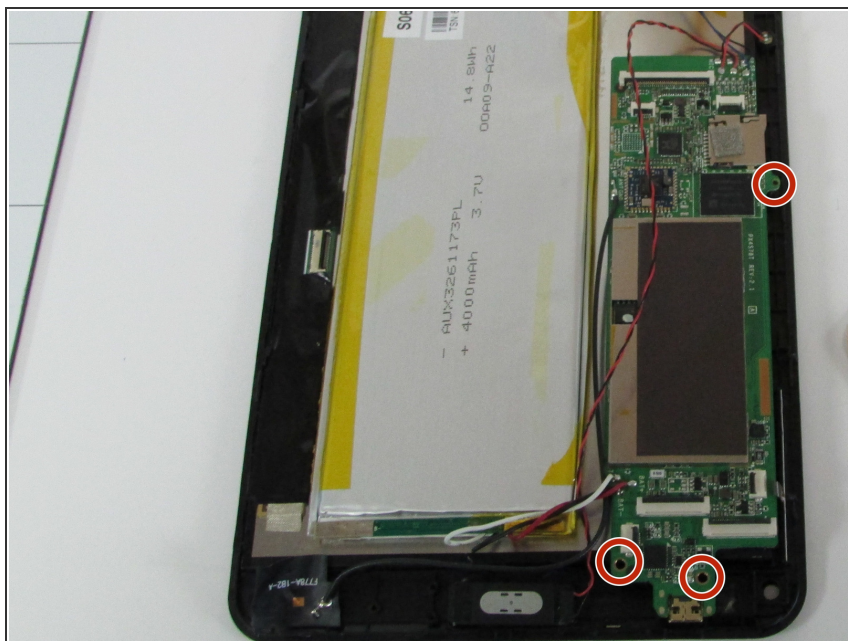
## Step 2

- Unscrew the motherboard.

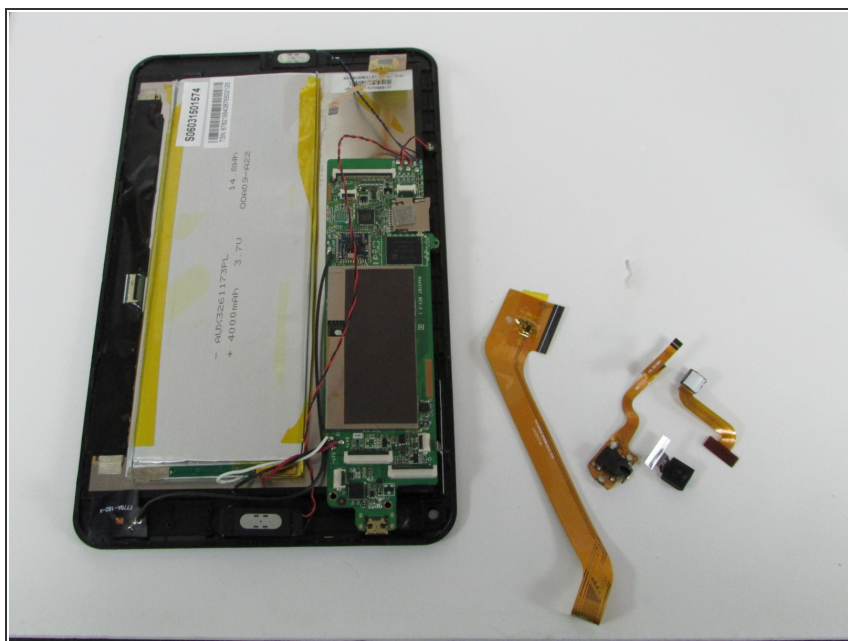
## Step 3

- Make sure all ribbons are disconnected.
